I had problems with my Kwikkee step Series 32. The steps on occasion would not retract. I had to tap the motor with a hammer while closing the door to get them to work even in doing this it was may or not work on the next try. I had lubricated the steps and linkage, and checked the door switch, controller, and battery voltage using the Technical tips on the Kwikkee Step internet site. Also I took the motor off the gear box and checked for any worn, or broken parts in the gear box. All checked out fine. This left the step motor as being the part that needed replacement.

Here are some of the photos from the motor replacement:

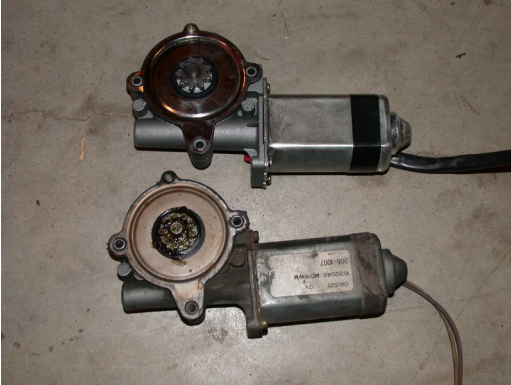
This is the comparison between the step motor and the new motor.

I did research and found that by looking on the NAPA internet site they had photos of the lift motors. I found that a 1986-1995 Ford Taurus left front window lift motor matched my motor. NAPA part # BK655-1395 \$63.99 I ordered my motor from Auto-Zone Manufactured by Dorman part# 742-206. This has a lifetime Warranty and was \$49.99.

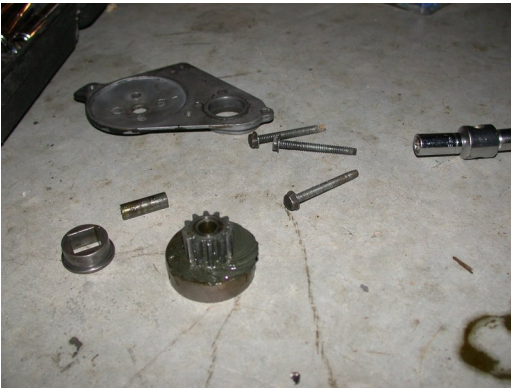
This shows the motor and linkage cover, the three bolts, that hold the motor and plate, the conversion gear, the conversion gear locator pin, and the linkage bushing.

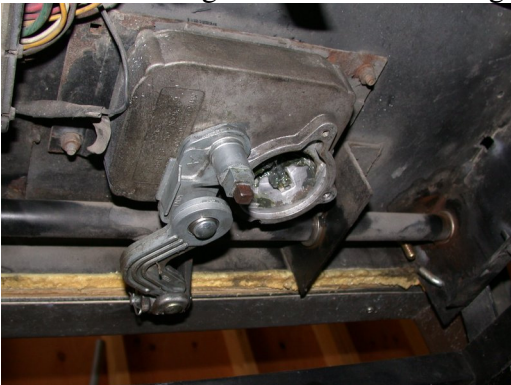
This shows the gearbox with the linkage in place

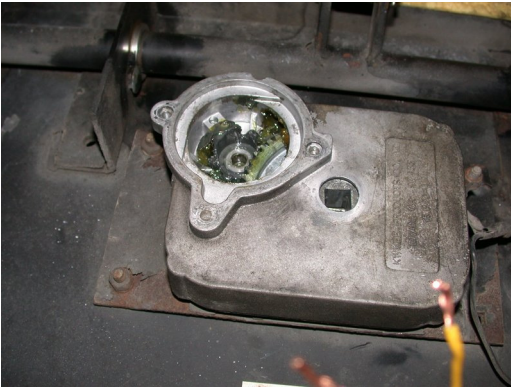
This shows the gear inside the gear box.
