Cargo Heater (RV3000) Repair

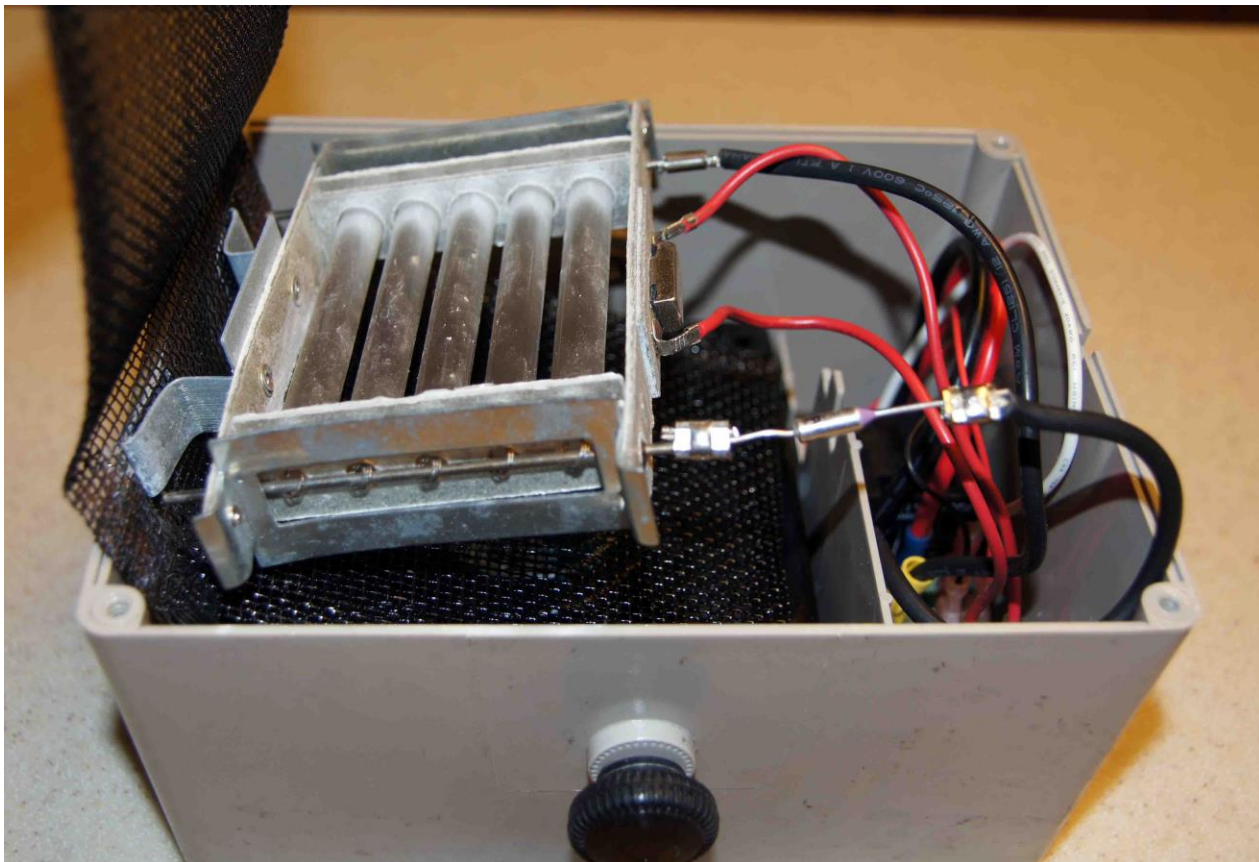
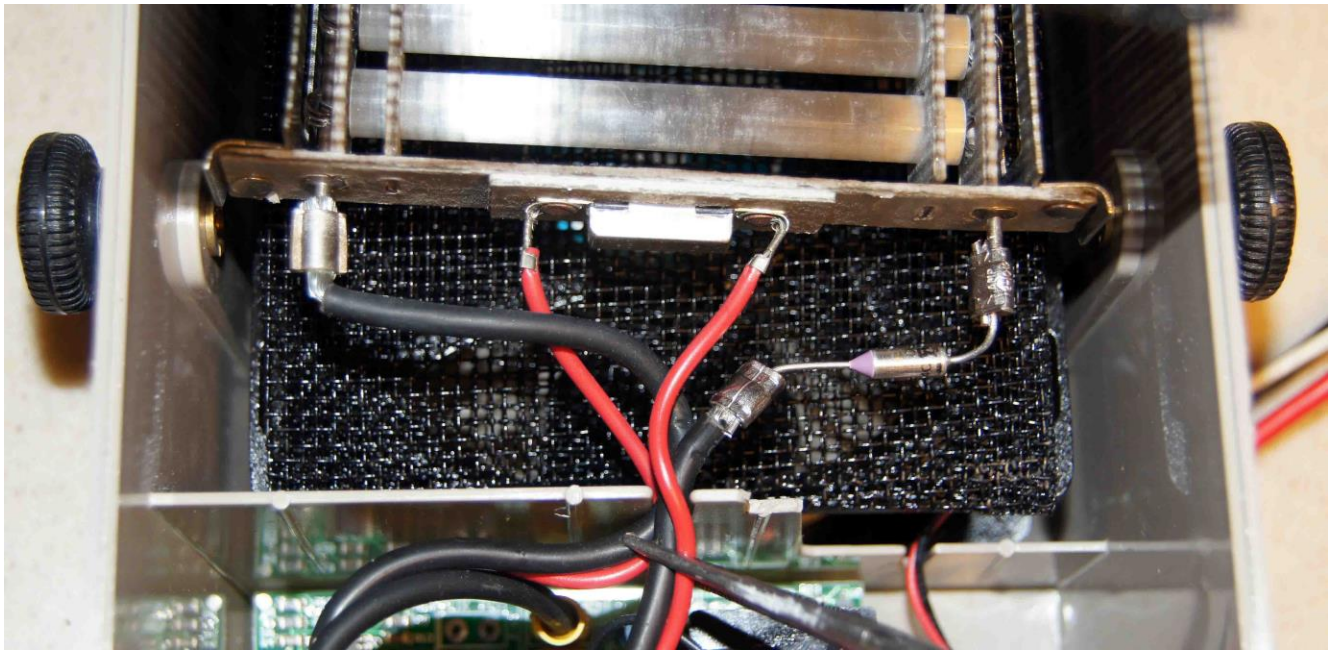
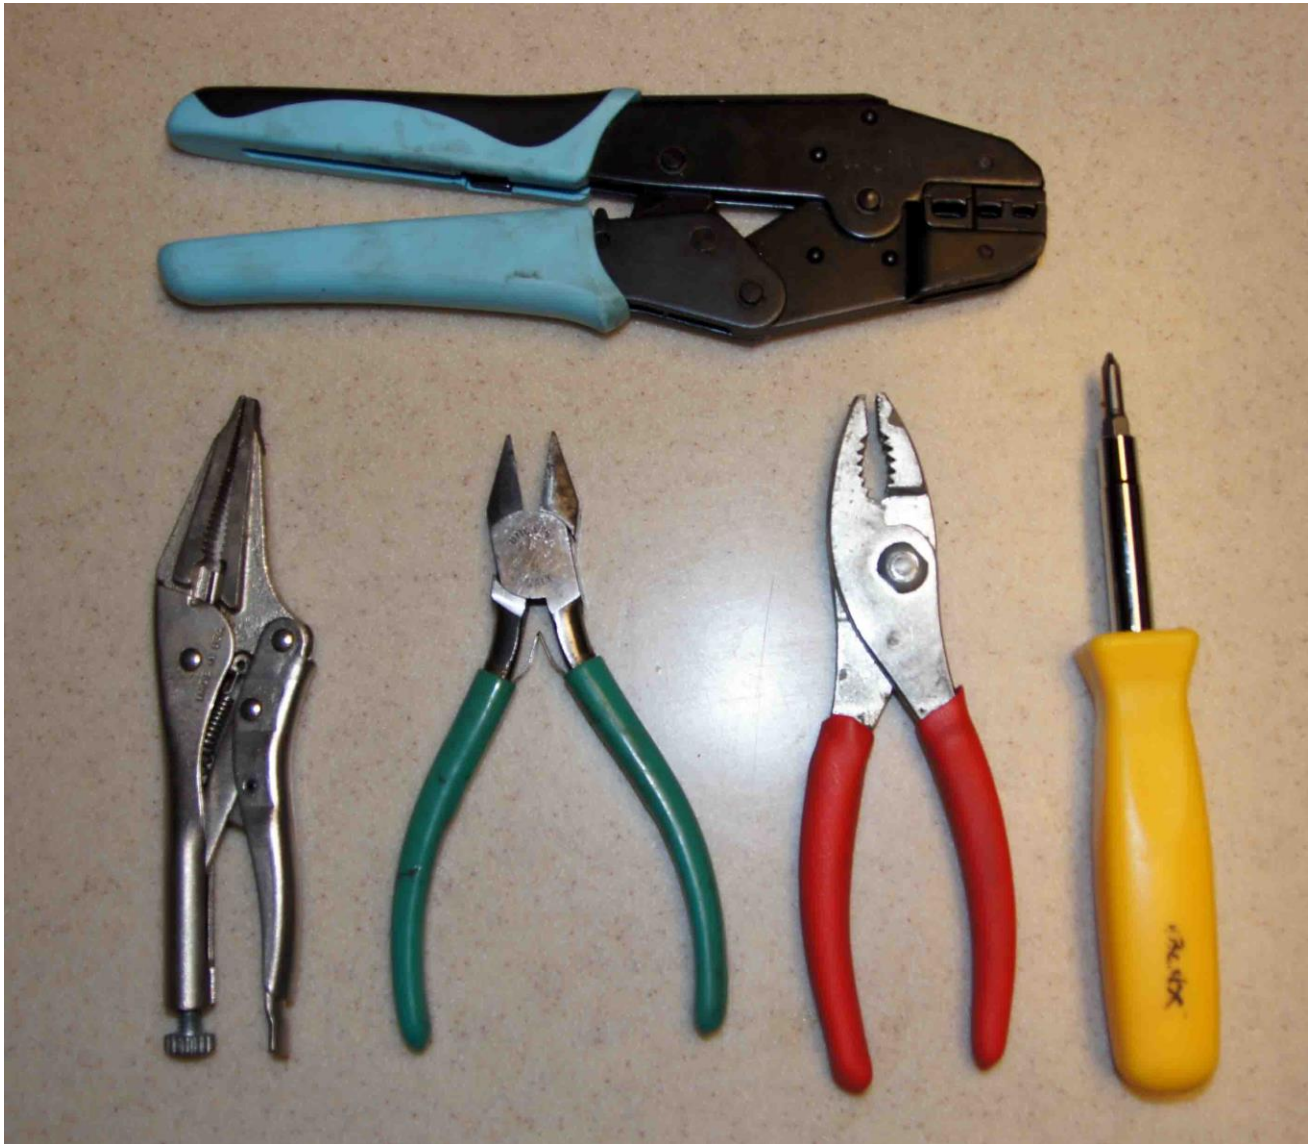
The included pictures show how to properly install and crimp the replacement. There was a lot of work that went into finding the proper crimp sleeve. A ratcheting style crimper was used...but if you had enough leverage, then Linesman's Pliers might suffice. A good, high pressure crimp is needed to provide proper current carrying capacity and also not overheat the fuse leads.

NOTE the polarity or the Color Indicator in the photos. Make sure that you install it THIS WAY.

The pictures show the Fuse without trimming the leads. Trim as needed, shorter the better. BUT, BE CAREFUL that the exposed leads do NOT touch any metal or such in the heater.

Frank did a lot of internet searching and found a 20 Amp 184 d C Thermal Cut Off Fuse and Crimping Sleeves from Newark Electronics.

- *Thermal Cut Off Fuse Newark PN 39T4439 (Thermodisc G5A01184C); \$1.92.*
- *Crimp Sleeve Newark PN 50F3313 (TE Amp 323754); \$1.20 for 2*
